COMMERCIAL WINDSTORM MITIGATION REPORT (OIR-B1-1802)

Countryside Key Homeowners Association, Inc.

201-215 Countryside Key Blvd

As of 4/29/2019

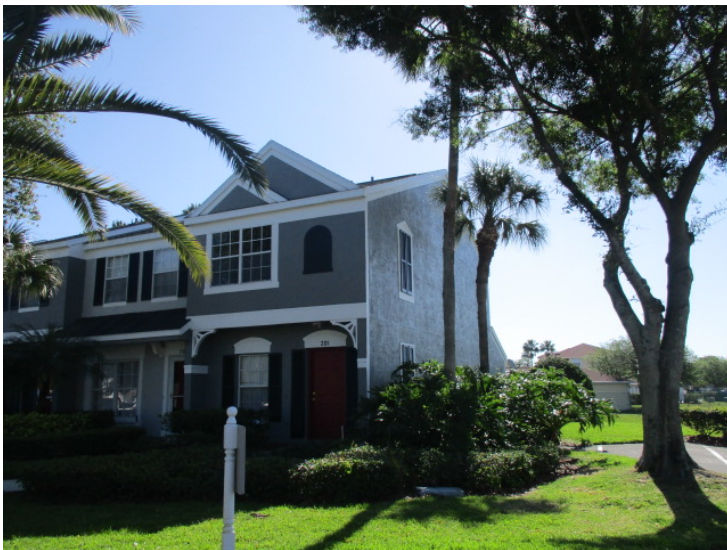
- 5. Roof Geometry:** **Other Roof**
Comments: Inspection verified a gable roof shape.
- 6. SWR:** **Unknown or Undetermined**
Comments: Due to no attic access we were unable to verify SWR.

Exterior Elevation

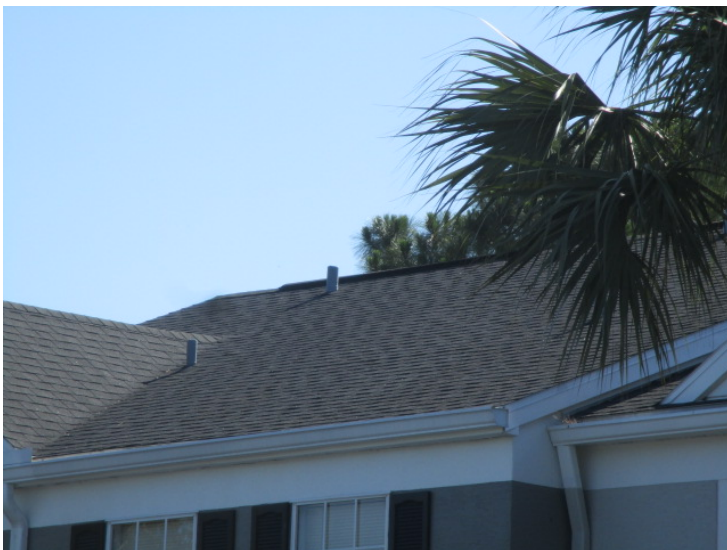
- 2. Roof Covering:** **FBC Equivalent**
Comments: The roof covering was replaced in 2012. The roof permit was confirmed and the permit numbers are 20120563-20120270. This roof was verified as meeting the building code requirements outlined on the mitigation affidavit.

Roof Construction
