## COMMERCIAL WINDSTORM MITIGATION REPORT (OIR-B1-1802)

Countryside Key Homeowners Association, Inc.

202-216 Countryside Key Blvd

As of 4/29/2019

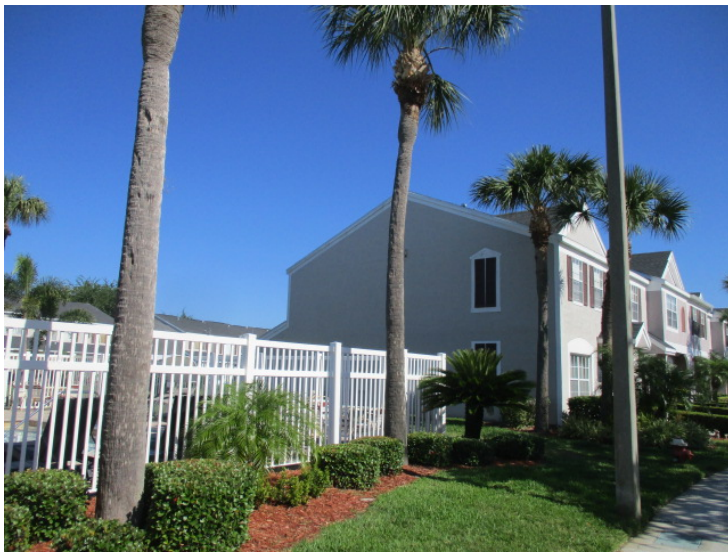
Exterior Elevation

- 5. Roof Geometry:**                    **Other Roof**  
Comments:                                      Inspection verified a gable roof shape.
- 6. SWR:**                                    **Unknown or Undetermined**  
Comments:                                      Due to no attic access we were unable to verify SWR.

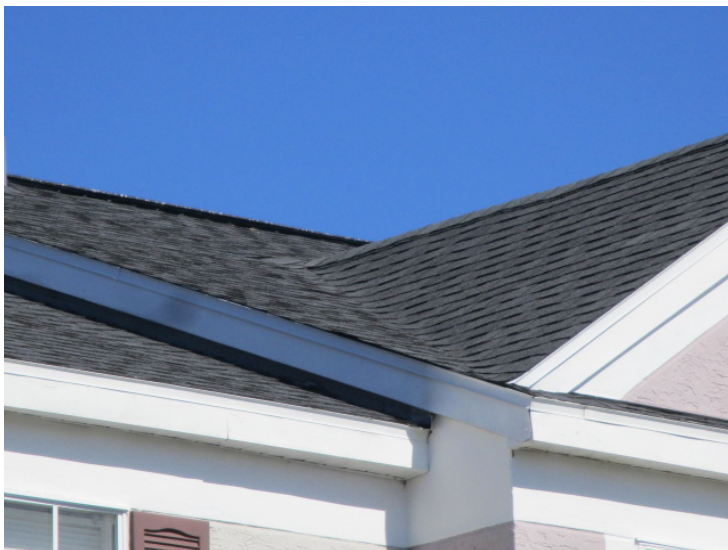
Roof Construction

- 2. Roof Covering:**                      **FBC Equivalent**  
Comments:                                      The roof covering was replaced in 2012. The roof permit was confirmed and the permit numbers are 20120799-20120808. This roof was verified as meeting the building code requirements outlined on the mitigation affidavit.
