# Windstorm Mitigation Report

Countryside Key

Oldsmar , FL

As of 04-25-2025 | FPAT File# MUD2522817

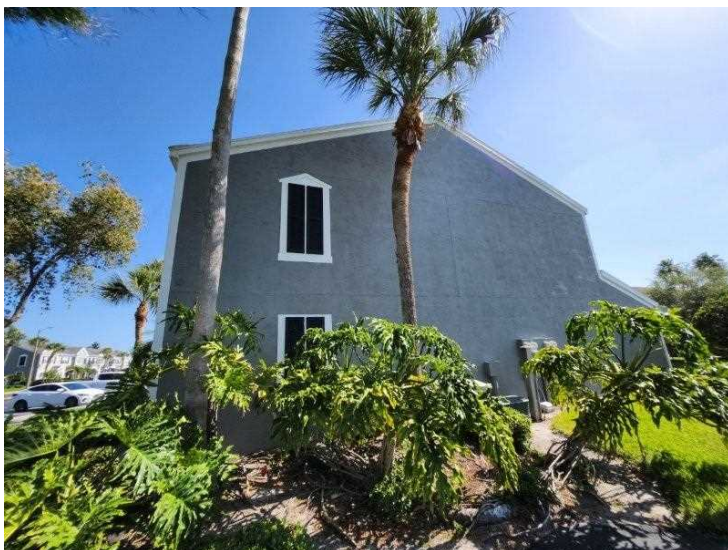
Exterior Elevation

| <b>7. Opening Protection:</b><br>Comments: | <b>None or Some Glazed Openings</b><br>No opening protection verified at the time of inspection. |

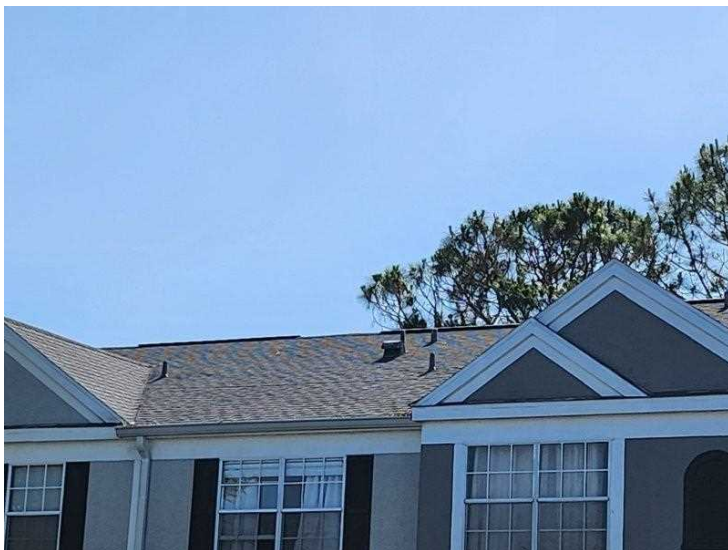
Roof Construction

| <b>2. Roof Covering:</b><br>Comments: | <b>FBC Equivalent</b><br>The roof covering was replaced in 2012. The roof permit was confirmed and the permit numbers are 20120563-20120270. This roof was verified as meeting the building code requirements outlined on the mitigation affidavit. |

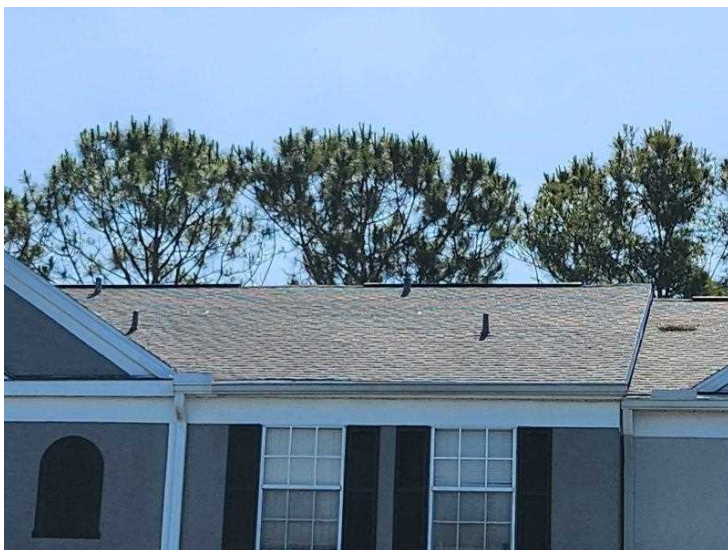
Roof Construction

| <b>6. SWR:</b><br>Comments: | <b>Unknown or Undetermined</b><br>Due to no attic access we were unable to verify SWR. |

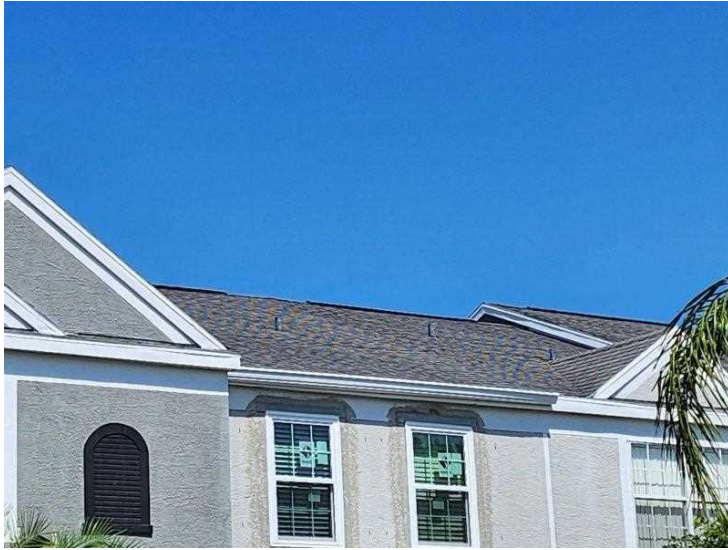
Roof Construction

| <b>2. Roof Covering:</b><br>Comments: | <b>FBC Equivalent</b><br>The roof covering was replaced in 2012. The roof permit was confirmed and the permit numbers are 20120804-20120795. This roof was verified as meeting the building code requirements outlined on the mitigation affidavit. |
