COMMERCIAL WINDSTORM MITIGATION REPORT (OIR-B1-1802)

Countryside Key Homeowners Association, Inc.

217-231 Countryside Key Blvd

As of 4/29/2019

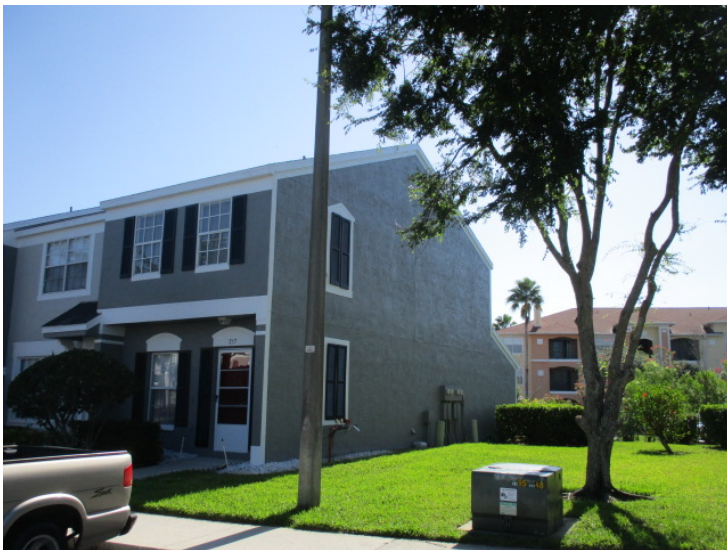
Exterior Elevation

- 7. Opening Protection:** **None or Some Glazed Openings**
Comments: No opening protection verified at the time of inspection.

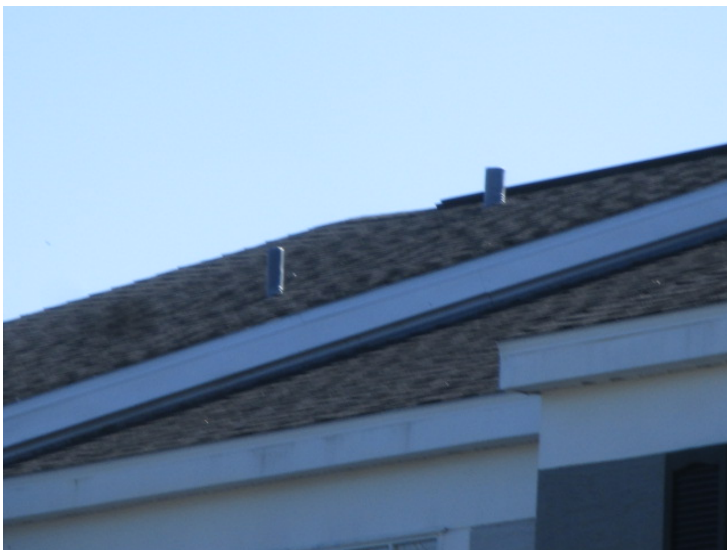
Roof Construction

- 2. Roof Covering:** **FBC Equivalent**
Comments: The roof covering was replaced in 2012. The roof permit was confirmed and the permit numbers are 20120290-20120296. This roof was verified as meeting the building code requirements outlined on the mitigation affidavit.

- 5. Roof Geometry:** **Other Roof**
Comments: Inspection verified a gable roof shape.
- 6. SWR:** **Unknown or Undetermined**
Comments: Due to no attic access we were unable to verify SWR.
