COMMERCIAL WINDSTORM MITIGATION REPORT (OIR-B1-1802)

Countryside Key Homeowners Association, Inc.

218-232 Countryside Key Blvd

As of 4/29/2019
FPAT File# MIT1811218

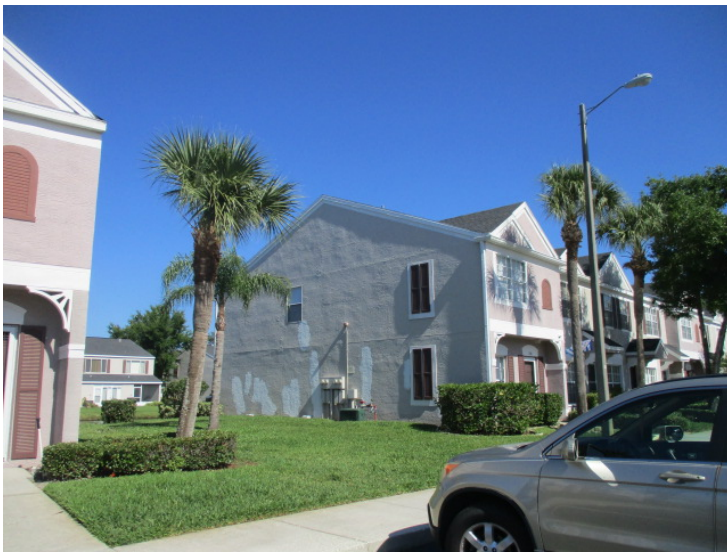
Exterior Elevation

- 5. Roof Geometry:** **Other Roof**
Comments: Inspection verified a gable roof shape.
- 6. SWR:** **Unknown or Undetermined**
Comments: Due to no attic access we were unable to verify SWR.

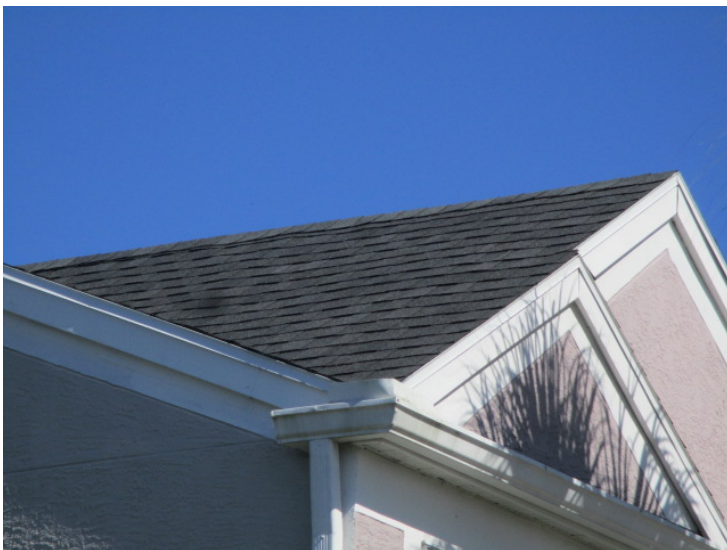
Roof Construction

- 2. Roof Covering:** **FBC Equivalent**
Comments: The roof covering was replaced in 2012. The roof permit was confirmed and the permit numbers are 20120804-20120795. This roof was verified as meeting the building code requirements outlined on the mitigation affidavit.
