COMMERCIAL WINDSTORM MITIGATION REPORT (OIR-B1-1802)

Countryside Key Homeowners Association, Inc.

234-248 Countryside Key Blvd

As of 4/29/2019

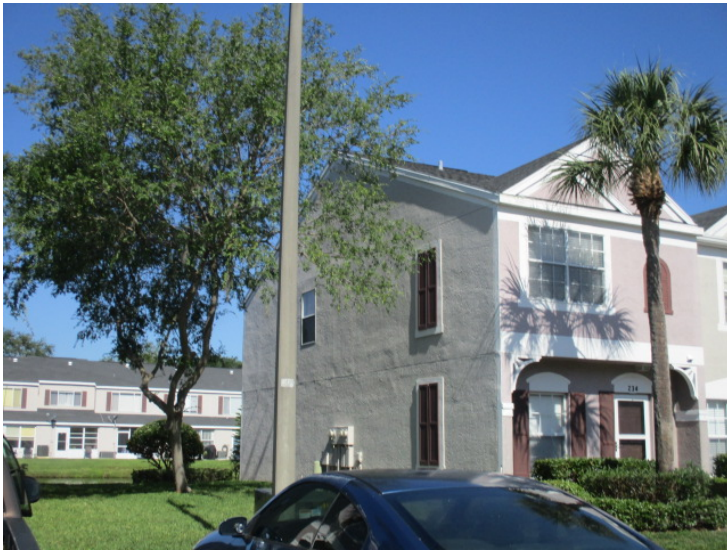
Exterior Elevation

- 5. Roof Geometry:** **Other Roof**
Comments: Inspection verified a gable roof shape.
- 6. SWR:** **Unknown or Undetermined**
Comments: Due to no attic access we were unable to verify SWR.

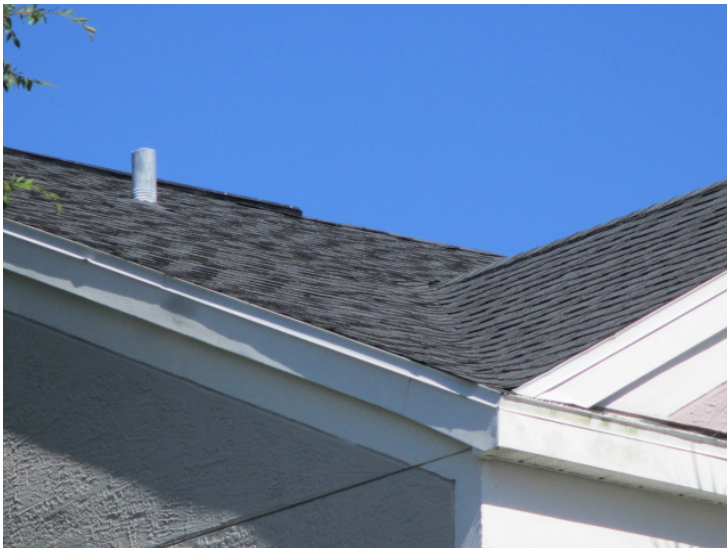
Roof Construction

- 2. Roof Covering:** **FBC Equivalent**
Comments: The roof covering was replaced in 2012. The roof permit was confirmed and the permit numbers are 20120822-20120829. This roof was verified as meeting the building code requirements outlined on the mitigation affidavit.
