COMMERCIAL WINDSTORM MITIGATION REPORT (OIR-B1-1802)

Countryside Key Homeowners Association, Inc.

249-263 Countryside Key Blvd

As of 4/29/2019

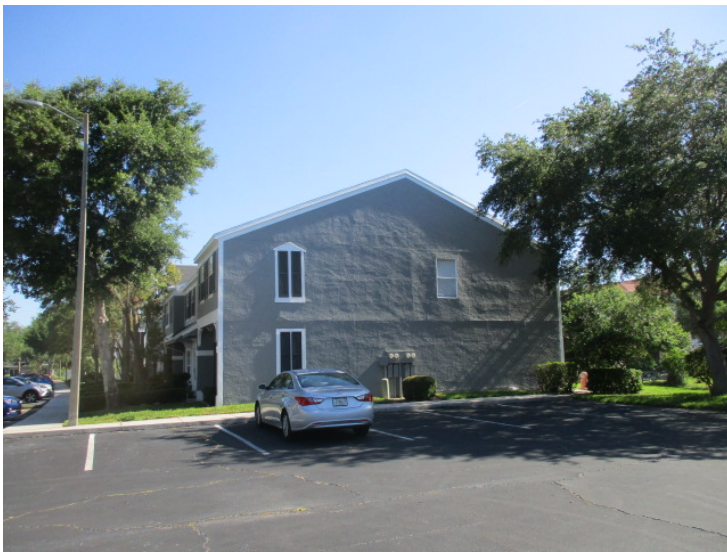
Exterior Elevation

- 5. Roof Geometry:** **Other Roof**
Comments: Inspection verified a gable roof shape.
- 6. SWR:** **Unknown or Undetermined**
Comments: Due to no attic access we were unable to verify SWR.

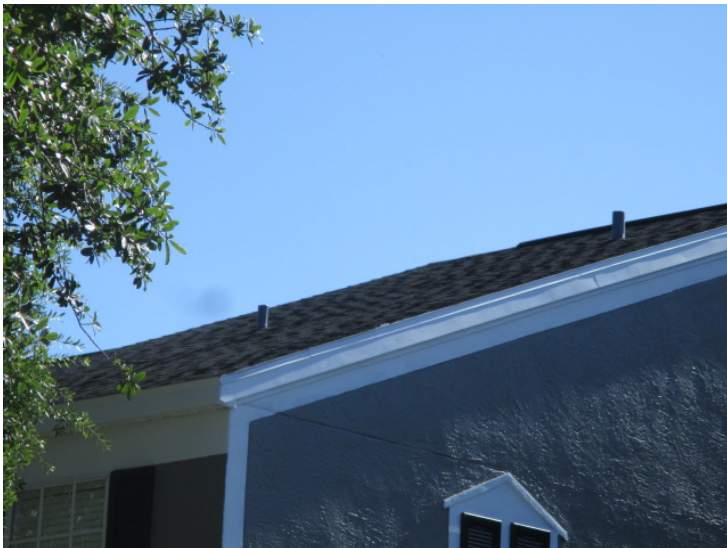
Roof Construction

- 2. Roof Covering:** **FBC Equivalent**
Comments: The roof covering was replaced in 2012. The roof permit was confirmed and the permit numbers are 20120372-20120382. This roof was verified as meeting the building code requirements outlined on the mitigation affidavit.
