## COMMERCIAL WINDSTORM MITIGATION REPORT (OIR-B1-1802)

Countryside Key Homeowners Association, Inc.

250-264 Countryside Key Blvd

As of 4/29/2019

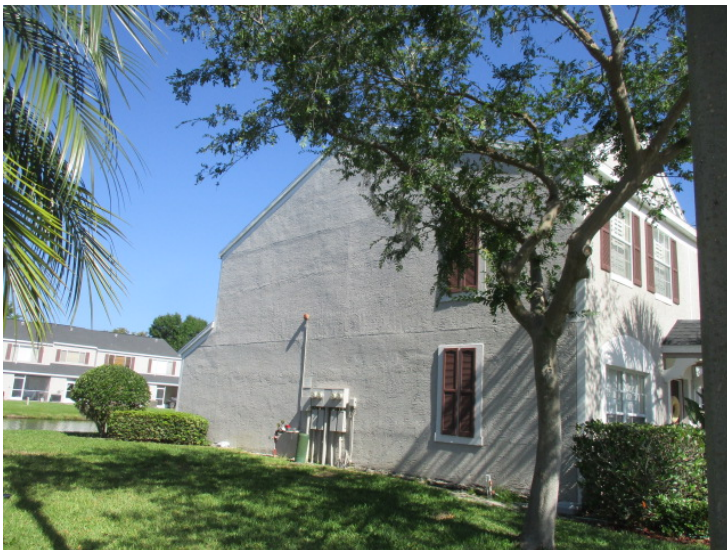
Exterior Elevation

- 5. Roof Geometry:**                    **Other Roof**  
Comments:                                      Inspection verified a gable roof shape.
- 6. SWR:**                                    **Unknown or Undetermined**  
Comments:                                      Due to no attic access we were unable to verify SWR.

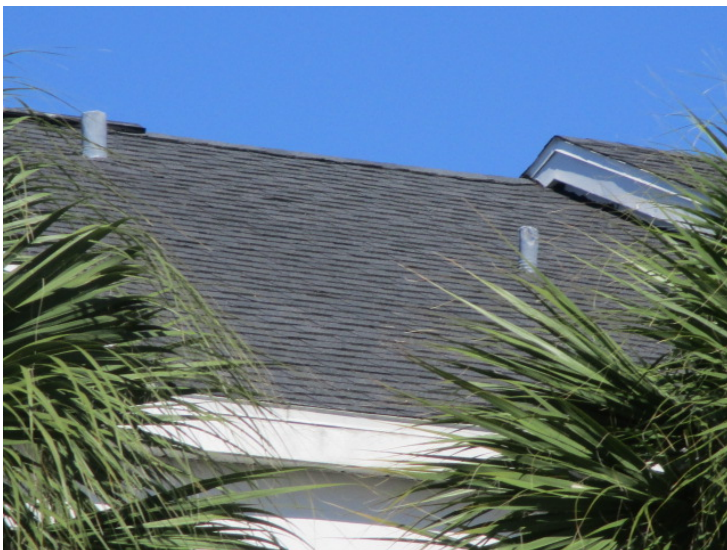
Roof Construction

- 2. Roof Covering:**                      **FBC Equivalent**  
Comments:                                      The roof covering was replaced in 2012. The roof permit was confirmed and the permit numbers are 20120856-20120855. This roof was verified as meeting the building code requirements outlined on the mitigation affidavit.
