COMMERCIAL WINDSTORM MITIGATION REPORT (OIR-B1-1802)

Countryside Key Homeowners Association, Inc.

265-279 Countryside Key Blvd

As of 4/29/2019

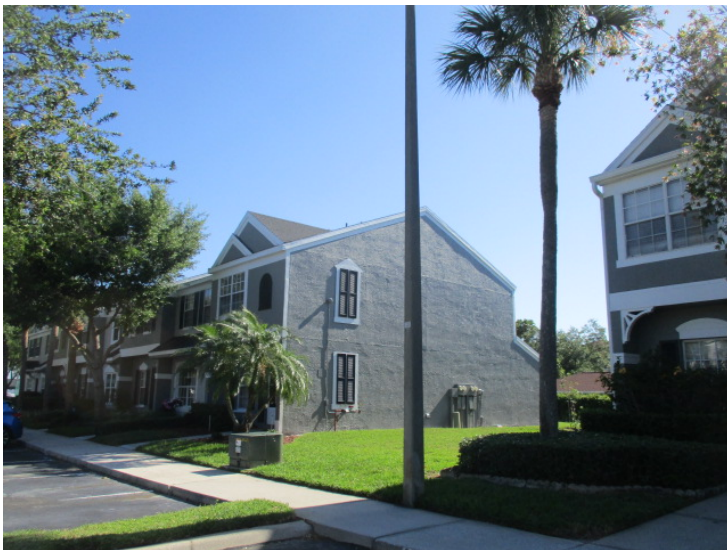
Exterior Elevation

- 5. Roof Geometry:** **Other Roof**
Comments: Inspection verified a gable roof shape.
- 6. SWR:** **Unknown or Undetermined**
Comments: Due to no attic access we were unable to verify SWR.

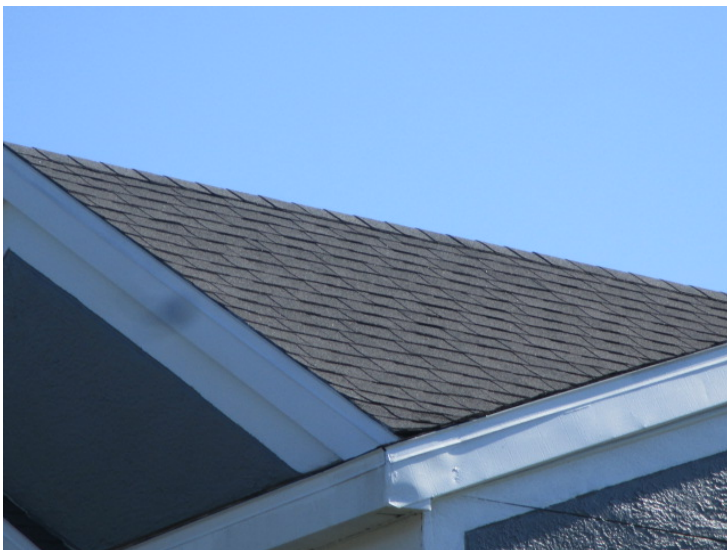
Roof Construction

- 2. Roof Covering:** **FBC Equivalent**
Comments: The roof covering was replaced in 2012. The roof permit was confirmed and the permit numbers are 20120563-20120270. This roof was verified as meeting the building code requirements outlined on the mitigation affidavit.
