COMMERCIAL WINDSTORM MITIGATION REPORT (OIR-B1-1802)

Countryside Key Homeowners Association, Inc.

285-295 Countryside Key Blvd

FPAT File# MIT1811218

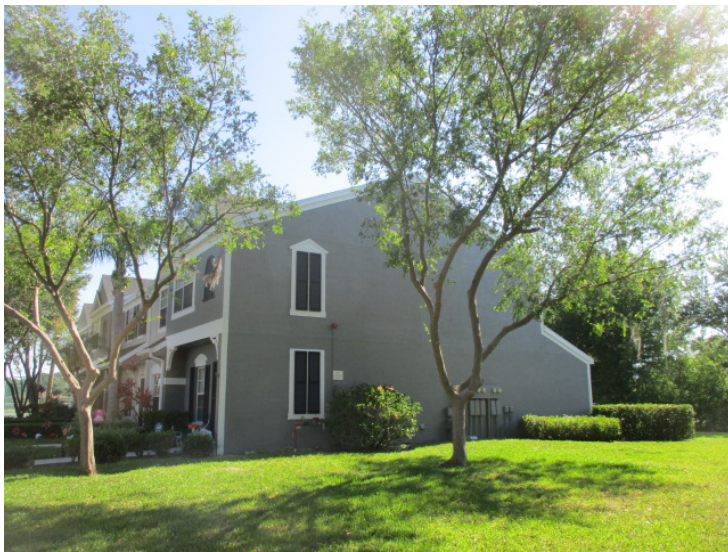
Exterior Elevation

- 5. Roof Geometry:** **Other Roof**
Comments: Inspection verified a gable roof shape.
- 6. SWR:** **Unknown or Undetermined**
Comments: Due to no attic access we were unable to verify SWR.

- 7. Opening Protection:** **None or Some Glazed Openings**
Comments: No opening protection verified at the time of inspection.

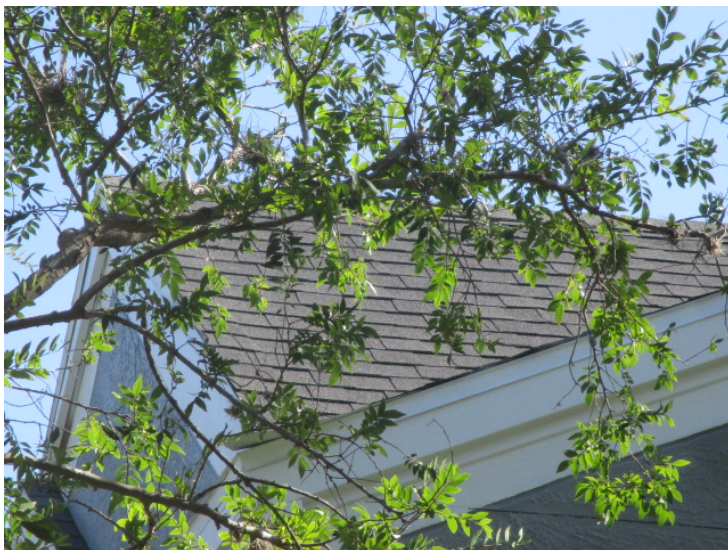
Roof Construction

- 2. Roof Covering:** **FBC Equivalent**
Comments: The roof covering was replaced in 2012. The roof permit was confirmed and the permit numbers are 20120421-20120426. This roof was verified as meeting the building code requirements outlined on the mitigation affidavit.
