## COMMERCIAL WINDSTORM MITIGATION REPORT (OIR-B1-1802)

Countryside Key Homeowners Association, Inc.

297-311 Countryside Key Blvd

As of 4/29/2019

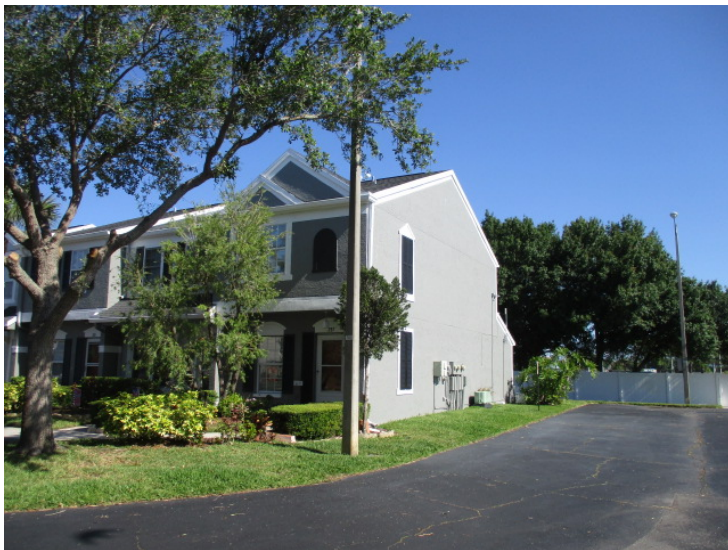
- 5. Roof Geometry:** **Other Roof**  
Comments: Inspection verified a gable roof shape.
- 6. SWR:** **Unknown or Undetermined**  
Comments: Due to no attic access we were unable to verify SWR.

Exterior Elevation

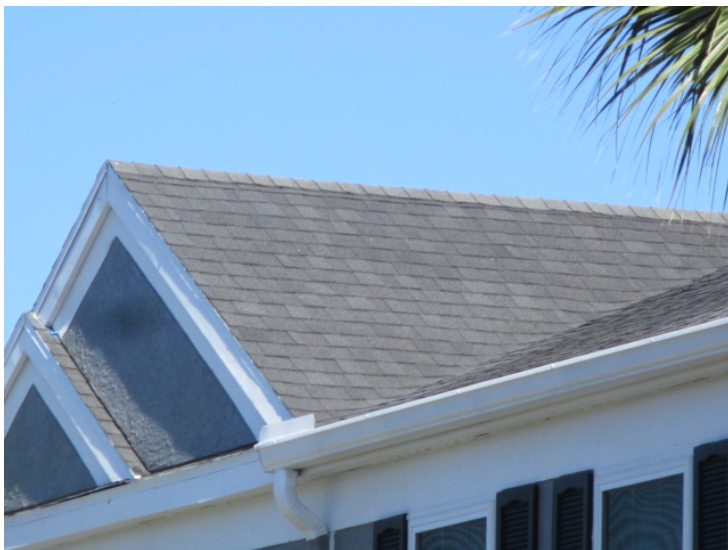
- 2. Roof Covering:** **FBC Equivalent**  
Comments: The roof covering was replaced in 2012. The roof permit was confirmed and the permit numbers are 20120428-20120435. This roof was verified as meeting the building code requirements outlined on the mitigation affidavit.

Roof Construction
