COMMERCIAL WINDSTORM MITIGATION REPORT (OIR-B1-1802)

Countryside Key Homeowners Association, Inc.

312-326 Countryside Key Blvd

FPAT File# MIT1811218

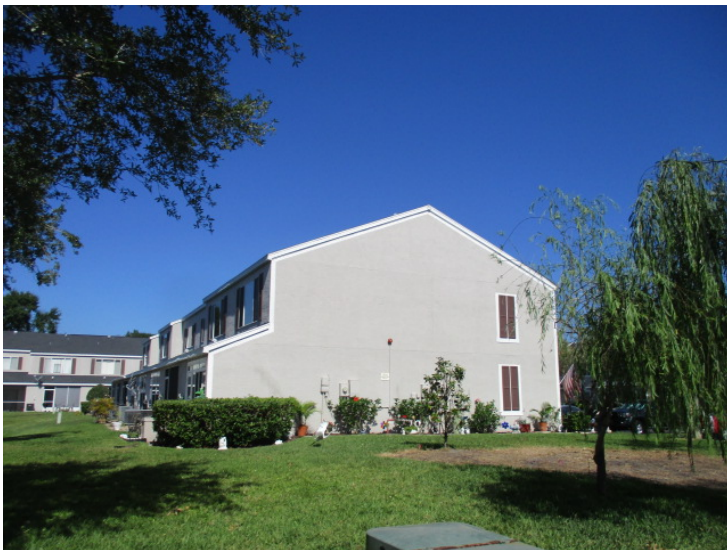
Exterior Elevation

- 5. Roof Geometry:** **Other Roof**
Comments: Inspection verified a gable roof shape.
- 6. SWR:** **Unknown or Undetermined**
Comments: Due to no attic access we were unable to verify SWR.

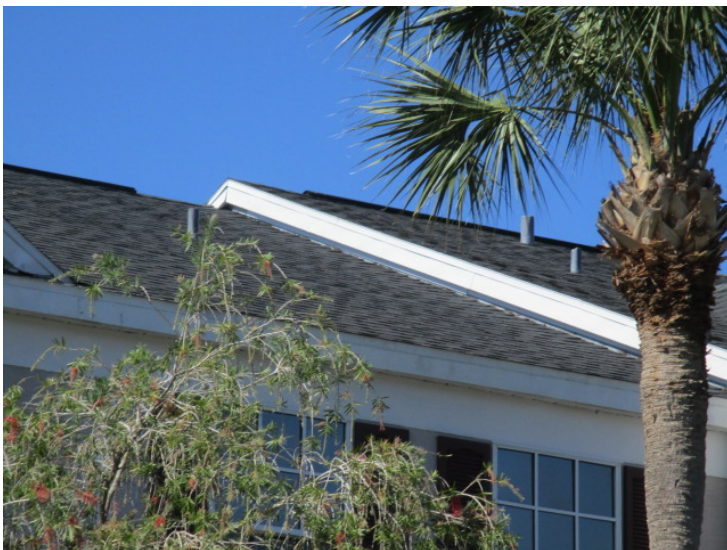
Roof Construction

- 2. Roof Covering:** **FBC Equivalent**
Comments: The roof covering was replaced in 2013. The roof permit was confirmed and the permit numbers are 20120863-20120870. This roof was verified as meeting the building code requirements outlined on the mitigation affidavit.
