COMMERCIAL WINDSTORM MITIGATION REPORT (OIR-B1-1802)

Countryside Key Homeowners Association, Inc.

313-327 Countryside Key Blvd

As of 4/29/2019

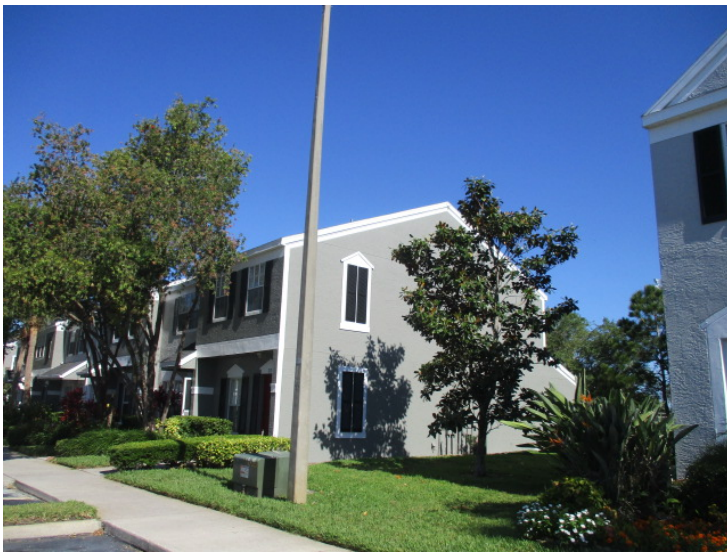
- 5. Roof Geometry:** **Other Roof**
Comments: Inspection verified a gable roof shape.
- 6. SWR:** **Unknown or Undetermined**
Comments: Due to no attic access we were unable to verify SWR.

Exterior Elevation

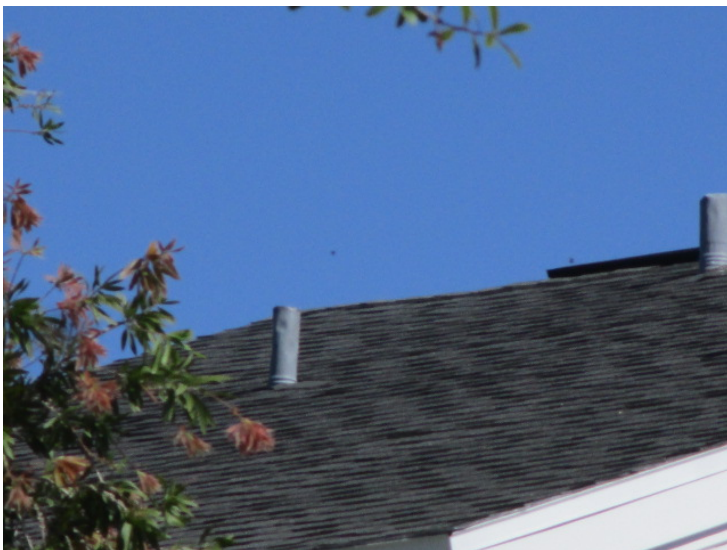
- 2. Roof Covering:** **FBC Equivalent**
Comments: The roof covering was replaced in 2012. The roof permit was confirmed and the permit numbers are 20120448-20120455. This roof was verified as meeting the building code requirements outlined on the mitigation affidavit.

Roof Construction
