COMMERCIAL WINDSTORM MITIGATION REPORT (OIR-B1-1802)

Countryside Key Homeowners Association, Inc.

328-338 Countryside Key Blvd

As of 4/29/2019

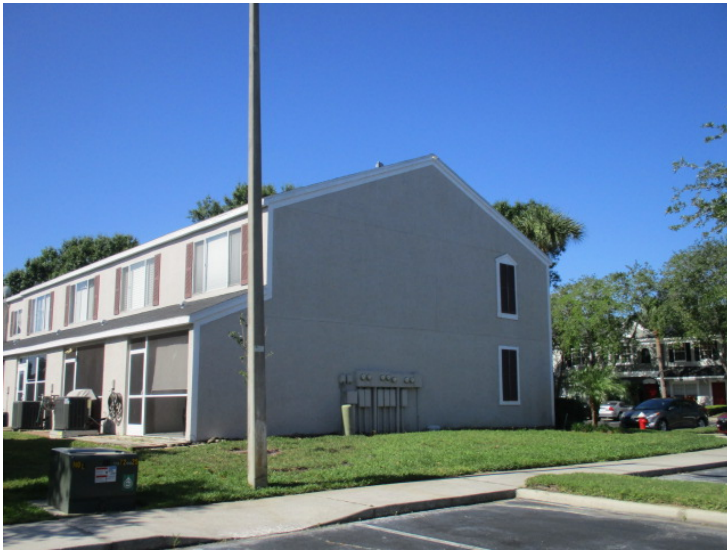
- 5. Roof Geometry:** **Other Roof**
Comments: Inspection verified a gable roof shape.
- 6. SWR:** **Unknown or Undetermined**
Comments: Due to no attic access we were unable to verify SWR.

Exterior Elevation

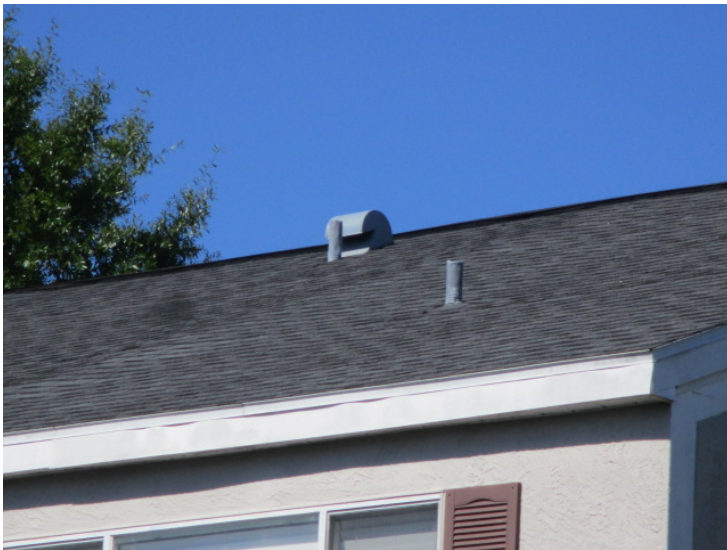
- 2. Roof Covering:** **FBC Equivalent**
Comments: The roof covering was replaced in 2013. The roof permit was confirmed and the permit numbers are 20120893-20120898. This roof was verified as meeting the building code requirements outlined on the mitigation affidavit.

Roof Construction
