## COMMERCIAL WINDSTORM MITIGATION REPORT (OIR-B1-1802)

Countryside Key Homeowners Association, Inc.

329-343 Countryside Key Blvd

As of 4/29/2019

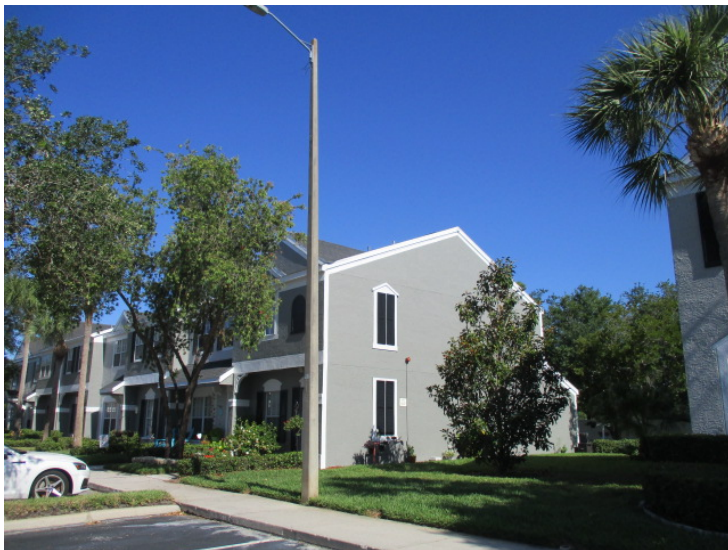
Exterior Elevation

- 5. Roof Geometry:**                    **Other Roof**  
Comments:                                      Inspection verified a gable roof shape.
- 6. SWR:**                                    **Unknown or Undetermined**  
Comments:                                      Due to no attic access we were unable to verify SWR.

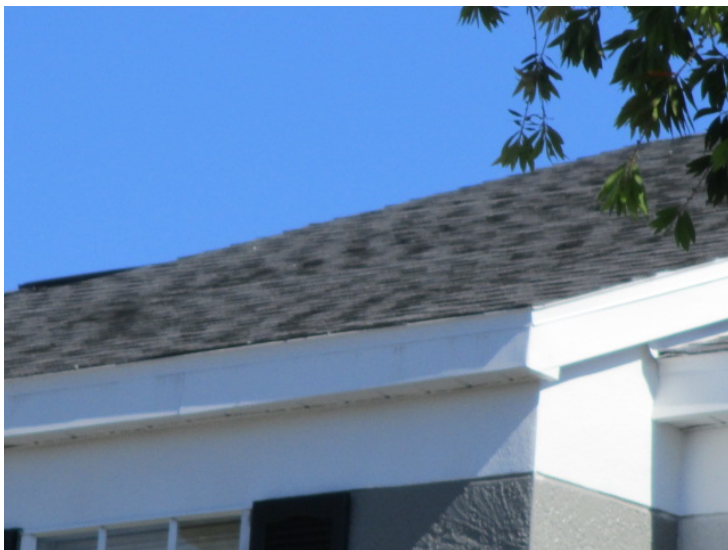
Roof Construction

- 2. Roof Covering:**                      **FBC Equivalent**  
Comments:                                      The roof covering was replaced in 2012. The roof permit was confirmed and the permit numbers are 20120456-20120463. This roof was verified as meeting the building code requirements outlined on the mitigation affidavit.
