COMMERCIAL WINDSTORM MITIGATION REPORT (OIR-B1-1802)

Countryside Key Homeowners Association, Inc.

345-359 Countryside Key Blvd

As of 4/29/2019

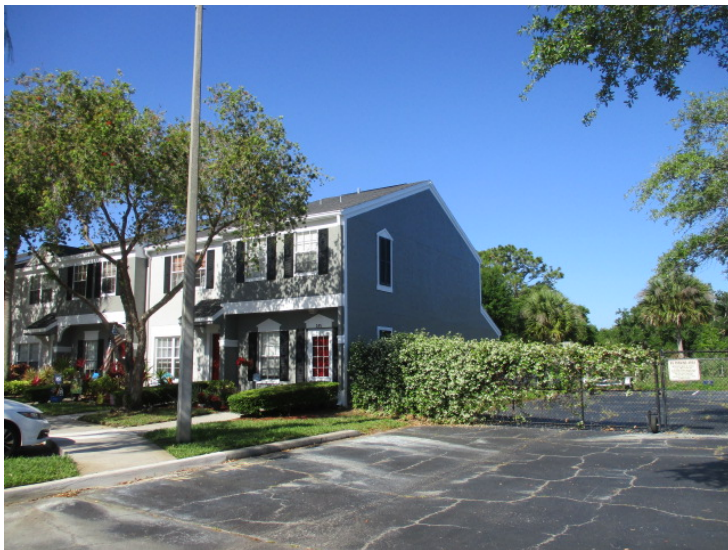
Exterior Elevation

- 5. Roof Geometry:** **Other Roof**
Comments: Inspection verified a gable roof shape.
- 6. SWR:** **Unknown or Undetermined**
Comments: Due to no attic access we were unable to verify SWR.

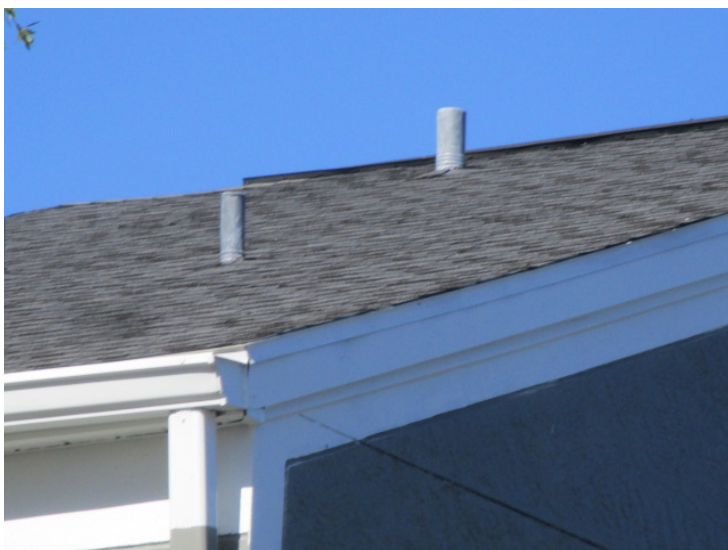
Roof Construction

- 2. Roof Covering:** **FBC Equivalent**
Comments: The roof covering was replaced in 2012. The roof permit was confirmed and the permit numbers are 20120469-20120478. This roof was verified as meeting the building code requirements outlined on the mitigation affidavit.
