COMMERCIAL WINDSTORM MITIGATION REPORT (OIR-B1-1802)

Countryside Key Homeowners Association, Inc.

360-374 Countryside Key Blvd

FPAT File# MIT1811218

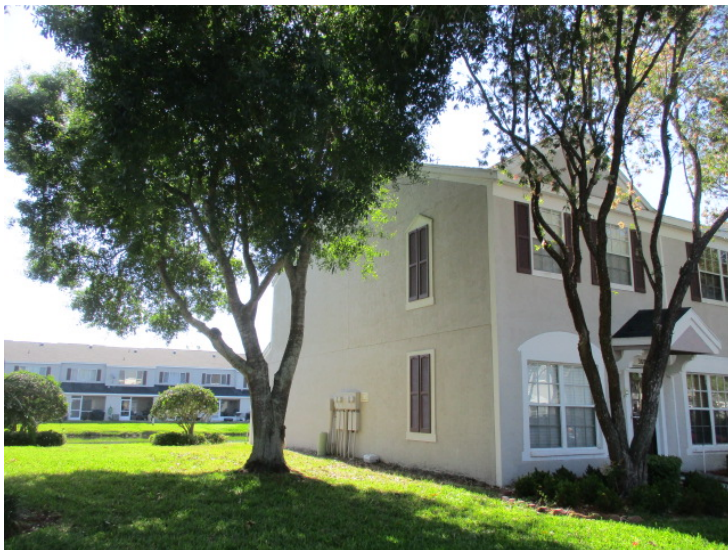
Exterior Elevation

- 5. Roof Geometry:** **Other Roof**
Comments: Inspection verified a gable roof shape.
- 6. SWR:** **Unknown or Undetermined**
Comments: Due to no attic access we were unable to verify SWR.

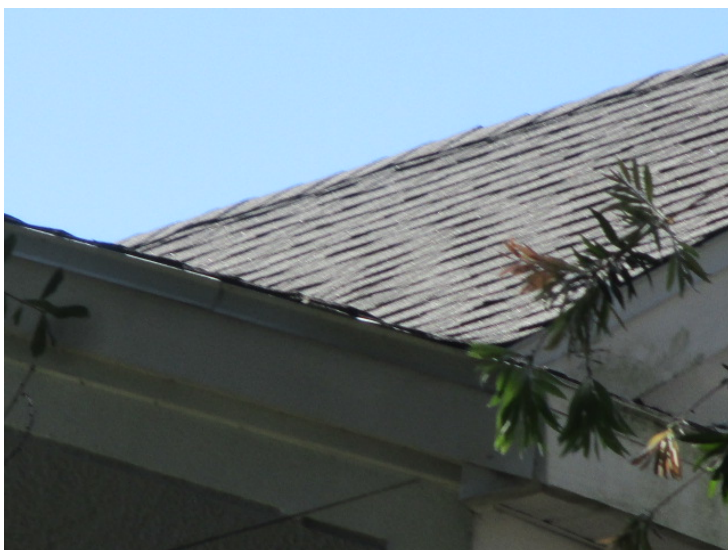
Roof Construction

- 2. Roof Covering:** **FBC Equivalent**
Comments: The roof covering was replaced in 2013. The roof permit was confirmed and the permit numbers are 20120903-20120910. This roof was verified as meeting the building code requirements outlined on the mitigation affidavit.
