COMMERCIAL WINDSTORM MITIGATION REPORT (OIR-B1-1802)

Countryside Key Homeowners Association, Inc.

361-375 Countryside Key Blvd

As of 4/29/2019

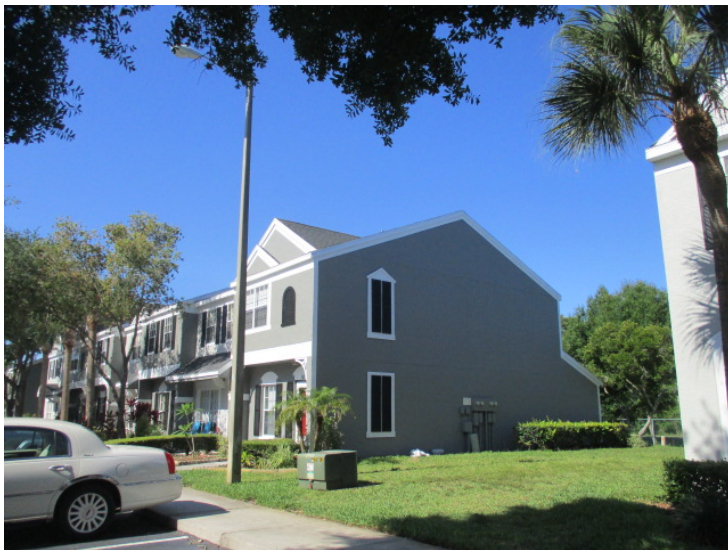
Exterior Elevation

- 5. Roof Geometry:** **Other Roof**
Comments: Inspection verified a gable roof shape.
- 6. SWR:** **Unknown or Undetermined**
Comments: Due to no attic access we were unable to verify SWR..

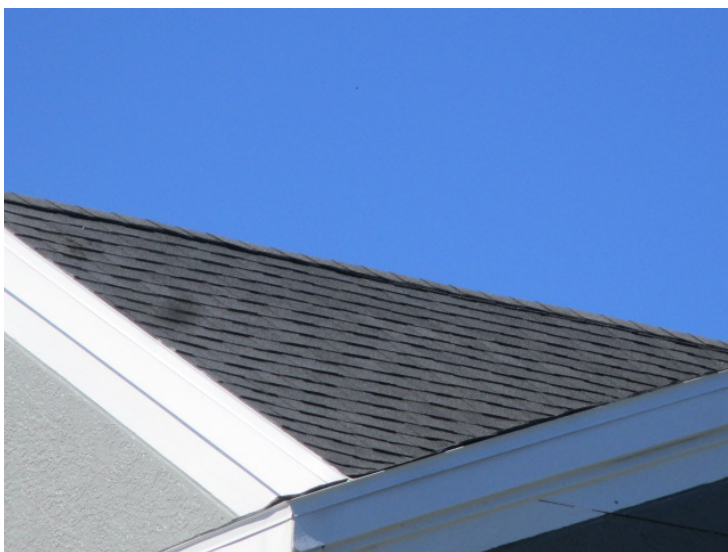
Roof Construction

- 2. Roof Covering:** **FBC Equivalent**
Comments: The roof covering was replaced in 2012. The roof permit was confirmed and the permit numbers are 20120903-20120492. This roof was verified as meeting the building code requirements outlined on the mitigation affidavit.
