COMMERCIAL WINDSTORM MITIGATION REPORT (OIR-B1-1802)

Countryside Key Homeowners Association, Inc.

376-390 Countryside Key Blvd

As of 4/29/2019

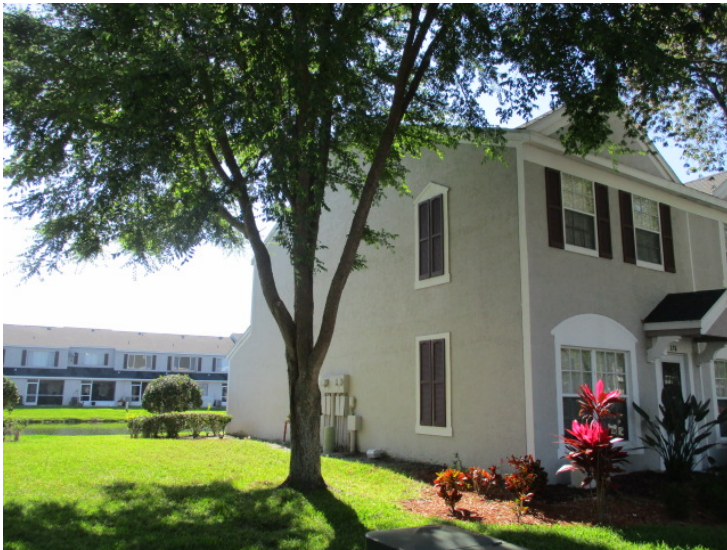
Exterior Elevation

- 5. Roof Geometry:** **Other Roof**
Comments: Inspection verified a gable roof shape.
- 6. SWR:** **Unknown or Undetermined**
Comments: Due to no attic access we were unable to verify SWR.

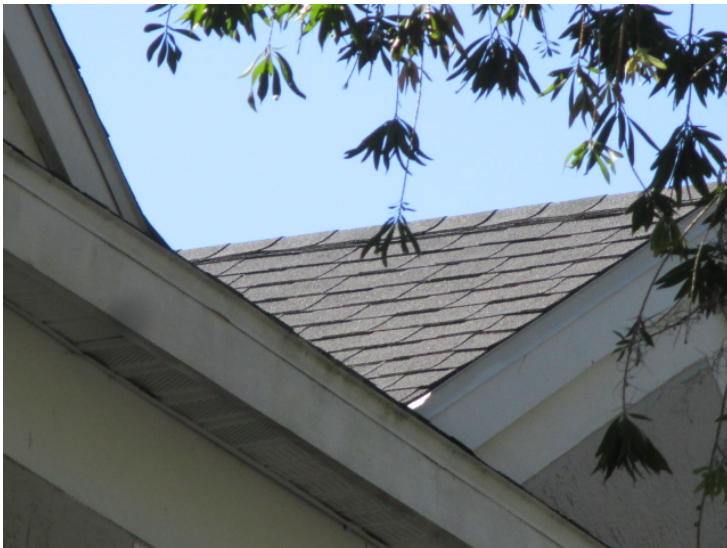
Roof Construction

- 2. Roof Covering:** **FBC Equivalent**
Comments: The roof covering was replaced in 2013. The roof permit was confirmed and the permit numbers are 20120662-20120669. This roof was verified as meeting the building code requirements outlined on the mitigation affidavit.
