## COMMERCIAL WINDSTORM MITIGATION REPORT (OIR-B1-1802)

Countryside Key Homeowners Association, Inc.

377-391 Countryside Key Blvd

As of 4/29/2019

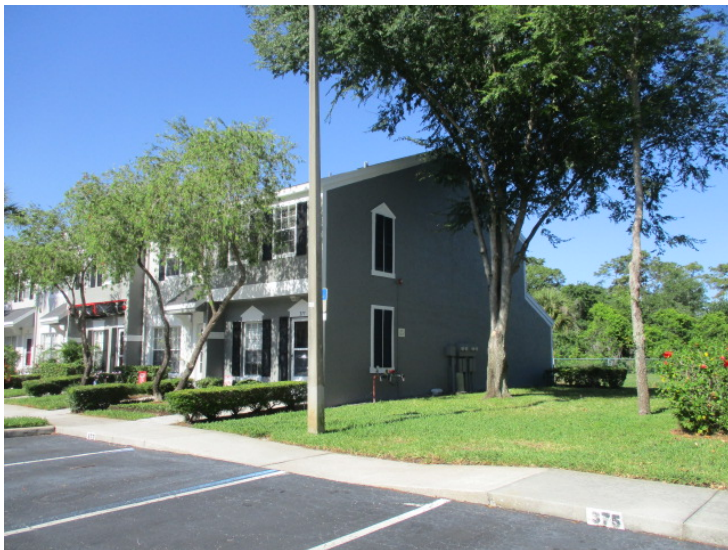
Exterior Elevation

- 5. Roof Geometry:**                    **Other Roof**  
Comments:                                      Inspection verified a gable roof shape.
- 6. SWR:**                                    **Unknown or Undetermined**  
Comments:                                      Due to no attic access we were unable to verify SWR.

- 7. Opening Protection:**            **None or Some Glazed Openings**  
Comments:                                      No opening protection verified at the time of inspection.

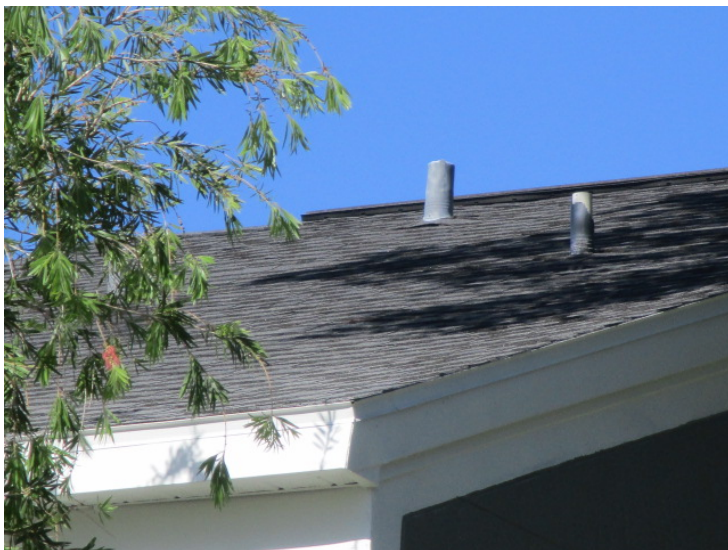
Roof Construction

- 2. Roof Covering:**                      **FBC Equivalent**  
Comments:                                      The roof covering was replaced in 2012. The roof permit was confirmed and the permit numbers are 20120510-20120518. This roof was verified as meeting the building code requirements outlined on the mitigation affidavit.
