## COMMERCIAL WINDSTORM MITIGATION REPORT (OIR-B1-1802)

Countryside Key Homeowners Association, Inc.

392-406 Countryside Key Blvd

As of 4/29/2019

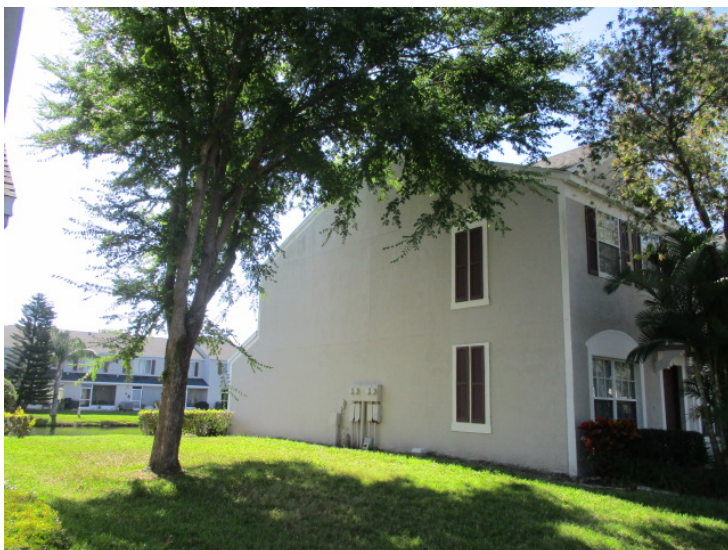
Exterior Elevation

- 5. Roof Geometry:** **Other Roof**  
Comments: Inspection verified a gable roof shape.
- 6. SWR:** **Unknown or Undetermined**  
Comments: Due to no attic access we were unable to verify SWR.

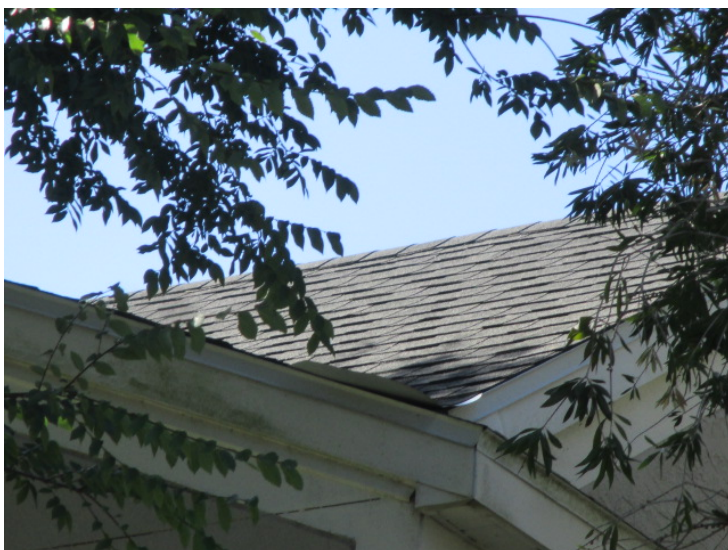
Roof Construction

- 2. Roof Covering:** **FBC Equivalent**  
Comments: The roof covering was replaced in 2013. The roof permit was confirmed and the permit numbers are 20120929-20120936. This roof was verified as meeting the building code requirements outlined on the mitigation affidavit.
