COMMERCIAL WINDSTORM MITIGATION REPORT (OIR-B1-1802)

Countryside Key Homeowners Association, Inc.

393-407 Countryside Key Blvd

As of 4/29/2019

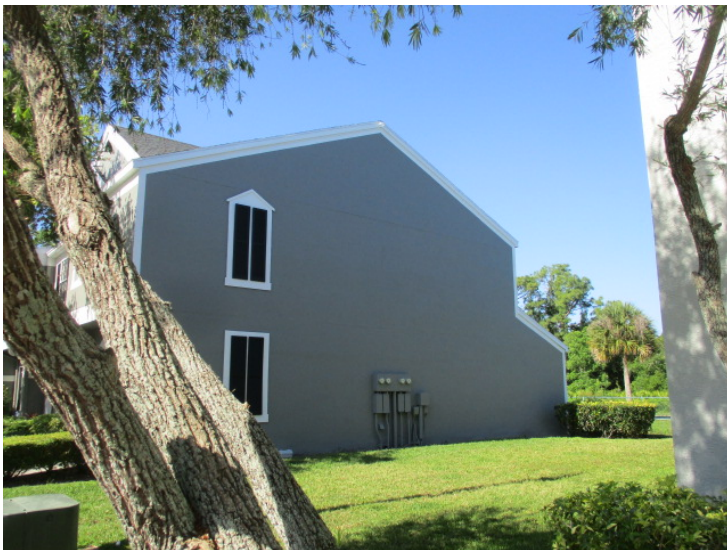
Exterior Elevation

- 5. Roof Geometry:** **Other Roof**
Comments: Inspection verified a gable roof shape.
- 6. SWR:** **Unknown or Undetermined**
Comments: Due to no attic access we were unable to verify SWR.

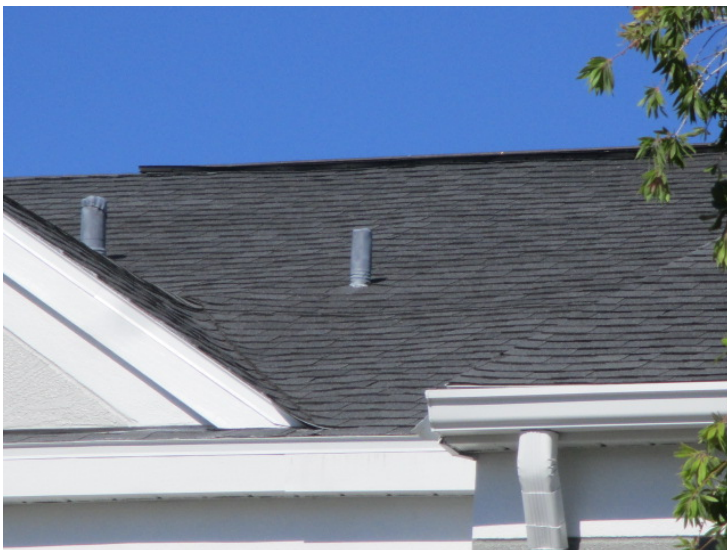
Roof Construction

- 2. Roof Covering:** **FBC Equivalent**
Comments: The roof covering was replaced in 2012. The roof permit was confirmed and the permit numbers are 20120529-20120599. This roof was verified as meeting the building code requirements outlined on the mitigation affidavit.
