COMMERCIAL WINDSTORM MITIGATION REPORT (OIR-B1-1802)

Countryside Key Homeowners Association, Inc.

409-423 Countryside Key Blvd

As of 4/29/2019

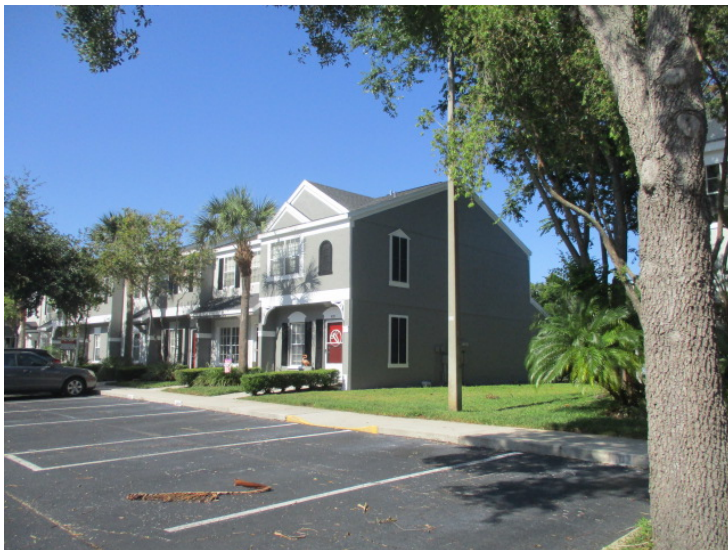
Exterior Elevation

- 5. Roof Geometry:** **Other Roof**
Comments: Inspection verified a gable roof shape.
- 6. SWR:** **Unknown or Undetermined**
Comments: Due to no attic access we were unable to verify SWR.

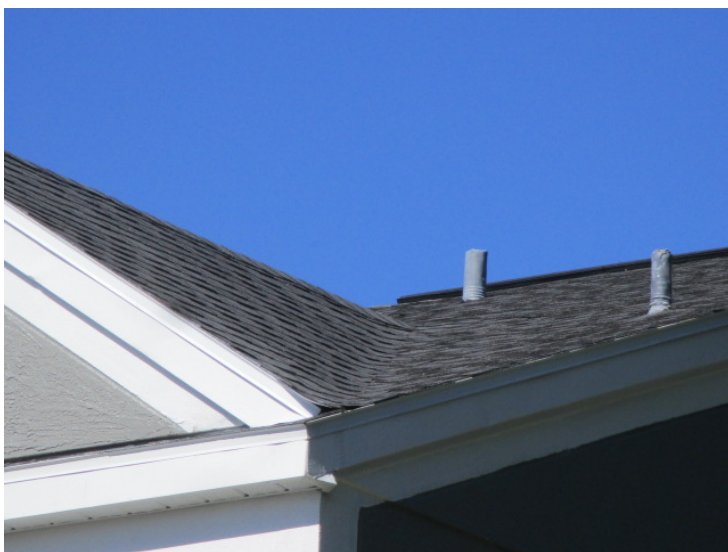
Roof Construction

- 2. Roof Covering:** **FBC Equivalent**
Comments: The roof covering was replaced in 2012. The roof permit was confirmed and the permit numbers are 20120734-20120740. This roof was verified as meeting the building code requirements outlined on the mitigation affidavit.
