## COMMERCIAL WINDSTORM MITIGATION REPORT (OIR-B1-1802)

Countryside Key Homeowners Association, Inc.

412-422 Countryside Key Blvd

As of 4/29/2019

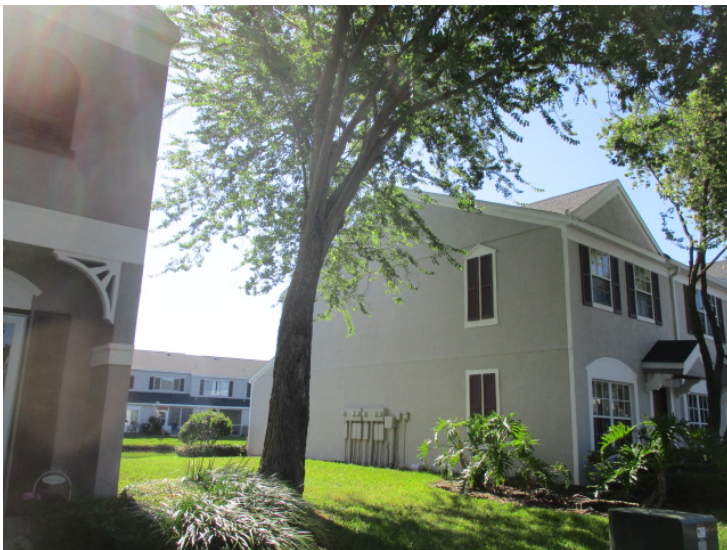
Exterior Elevation

- 5. Roof Geometry:** **Other Roof**  
Comments: Inspection verified a gable roof shape.
- 6. SWR:** **Unknown or Undetermined**  
Comments: Due to no attic access we were unable to verify SWR.

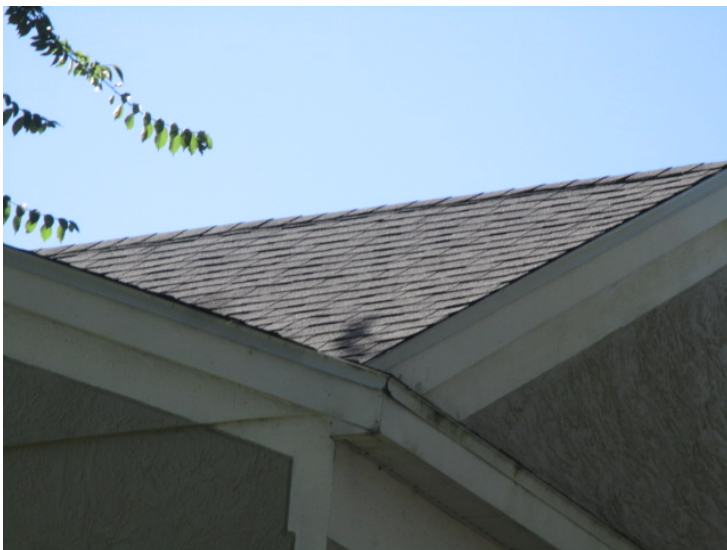
Roof Construction

- 2. Roof Covering:** **FBC Equivalent**  
Comments: The roof covering was replaced in 2013. The roof permit was confirmed and the permit numbers are 20120629-20120634. This roof was verified as meeting the building code requirements outlined on the mitigation affidavit.
