COMMERCIAL WINDSTORM MITIGATION REPORT (OIR-B1-1802)

Countryside Key Homeowners Association, Inc.

425-435 Countryside Key Blvd

As of 4/29/2019
FPAT File# MIT1811218

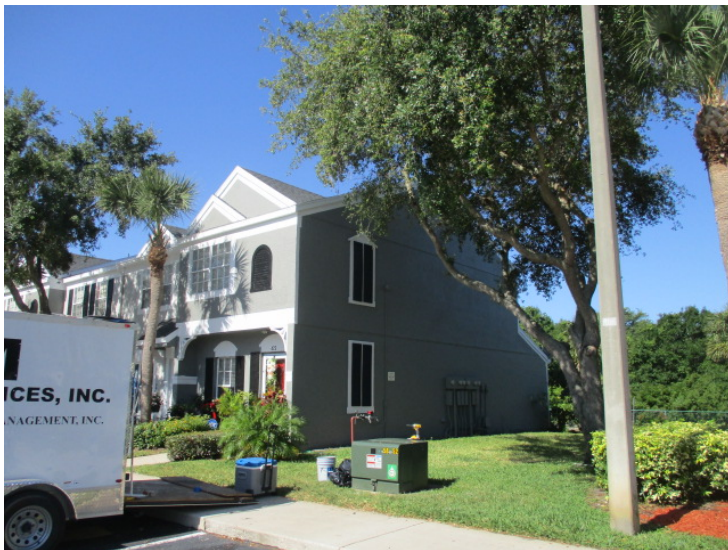
Exterior Elevation

- 5. Roof Geometry:** **Other Roof**
Comments: Inspection verified a gable roof shape.
- 6. SWR:** **Unknown or Undetermined**
Comments: Due to no attic access we were unable to verify SWR.

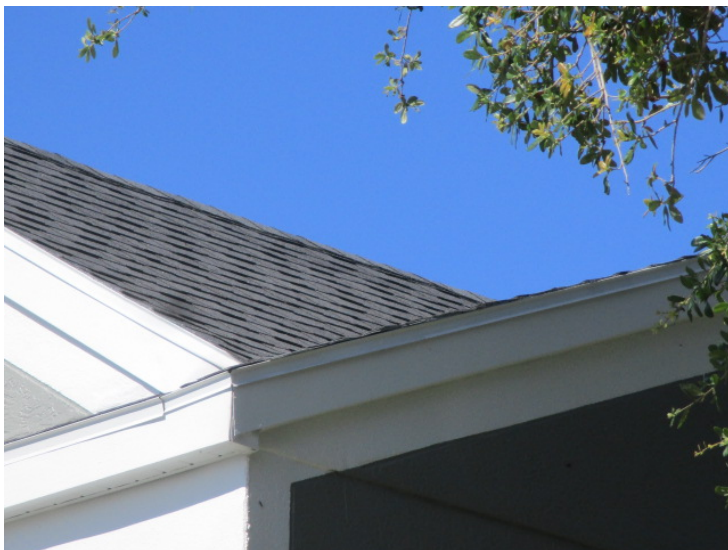
Roof Construction

- 2. Roof Covering:** **FBC Equivalent**
Comments: The roof covering was replaced in 2012. The roof permit was confirmed and the permit numbers are 20120607-20120612. This roof was verified as meeting the building code requirements outlined on the mitigation affidavit.
