## COMMERCIAL WINDSTORM MITIGATION REPORT (OIR-B1-1802)

Countryside Key Homeowners Association, Inc.

428-438 Countryside Key Blvd

As of 4/29/2019

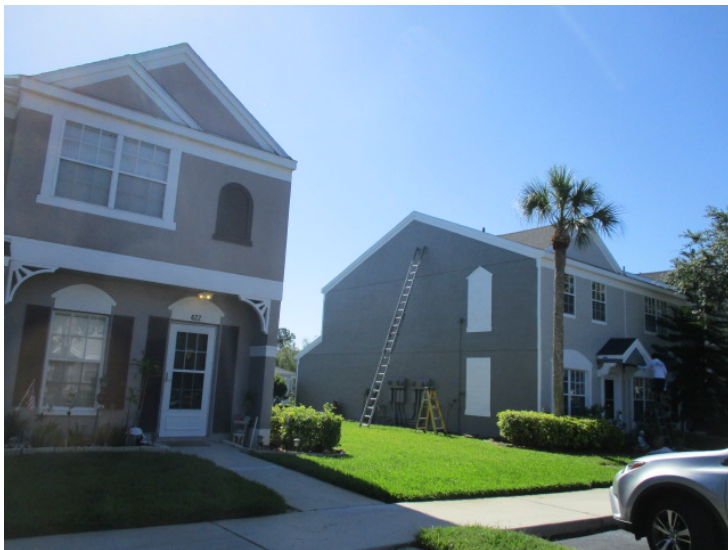
Exterior Elevation

- 5. Roof Geometry:**                    **Other Roof**  
Comments:                                      Inspection verified a gable roof shape.
- 6. SWR:**                                    **Unknown or Undetermined**  
Comments:                                      Due to no attic access we were unable to verify SWR.

- 7. Opening Protection:**            **None or Some Glazed Openings**  
Comments:                                      No opening protection verified at the time of inspection.

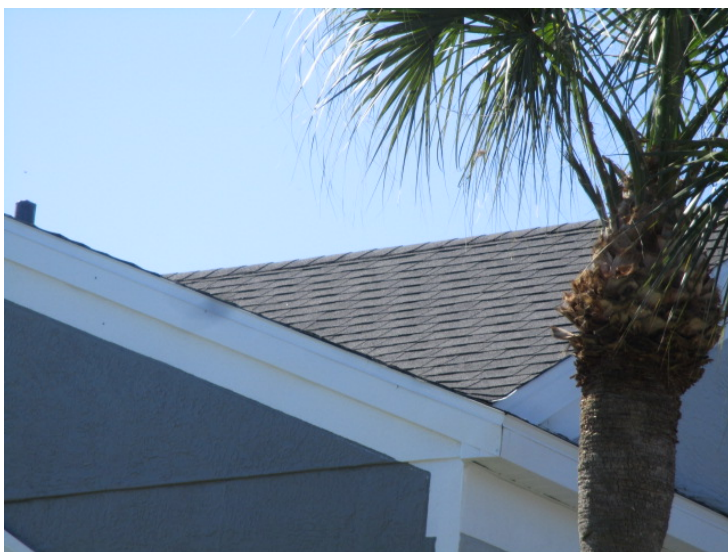
Roof Construction

- 2. Roof Covering:**                      **FBC Equivalent**  
Comments:                                      The roof covering was replaced in 2013. The roof permit was confirmed and the permit numbers are 20120948-20120953. This roof was verified as meeting the building code requirements outlined on the mitigation affidavit.
