COMMERCIAL WINDSTORM MITIGATION REPORT (OIR-B1-1802)

Countryside Key Homeowners Association, Inc.

441-451 Countryside Key Blvd

As of 4/29/2019

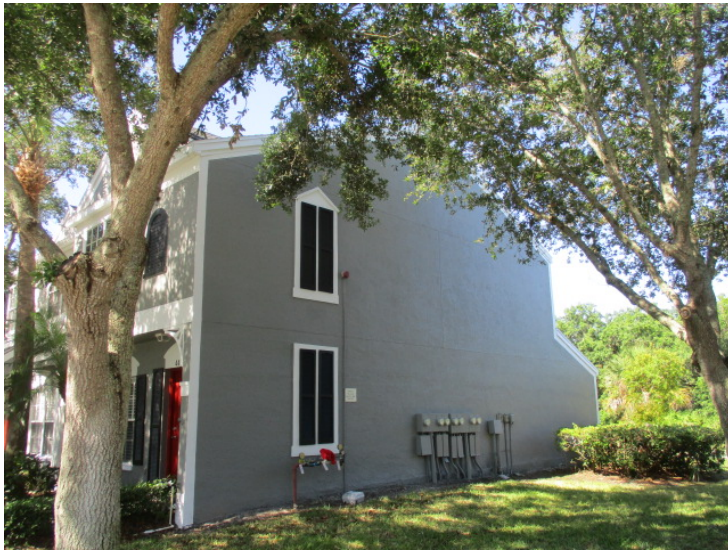
- 5. Roof Geometry:** **Other Roof**
Comments: Inspection verified a gable roof shape.
- 6. SWR:** **Unknown or Undetermined**
Comments: Due to no attic access we were unable to verify SWR.

Exterior Elevation

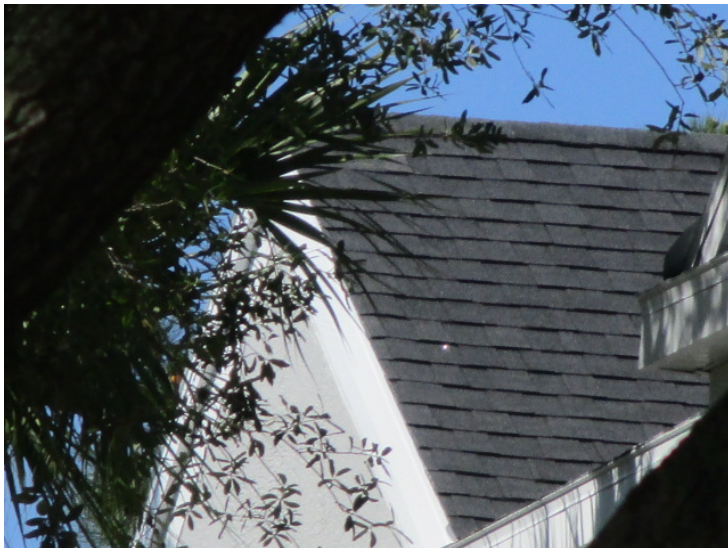
- 2. Roof Covering:** **FBC Equivalent**
Comments: The roof covering was replaced in 2012. The roof permit was confirmed and the permit numbers are 20120761-20120762. This roof was verified as meeting the building code requirements outlined on the mitigation affidavit.

Roof Construction
