## COMMERCIAL WINDSTORM MITIGATION REPORT (OIR-B1-1802)

Countryside Key Homeowners Association, Inc.

457-471 Countryside Key Blvd

As of 4/29/2019

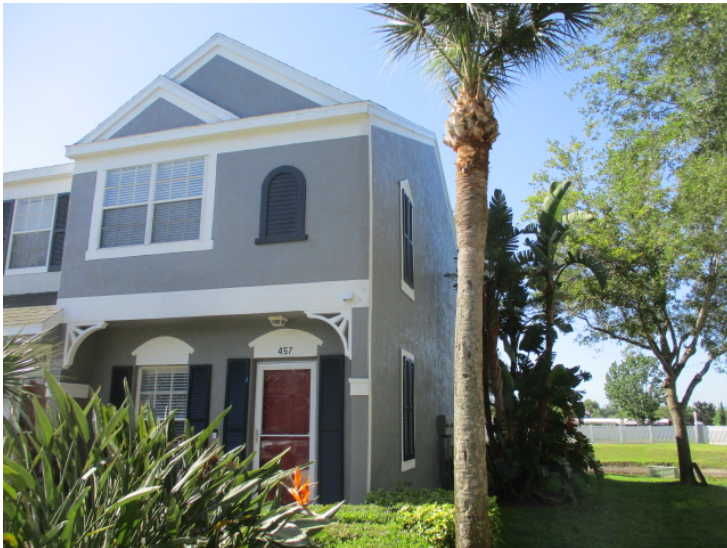
Exterior Elevation

- 5. Roof Geometry:** **Other Roof**  
Comments: Inspection verified a gable roof shape.
- 6. SWR:** **Unknown or Undetermined**  
Comments: Due to no attic access we were unable to verify SWR.

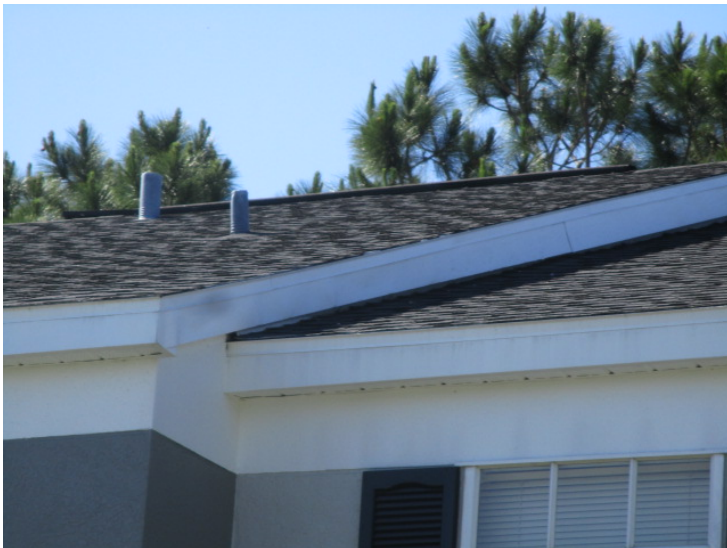
Roof Construction

- 2. Roof Covering:** **FBC Equivalent**  
Comments: The roof covering was replaced in 2012. The roof permit was confirmed and the permit numbers are 20120744-20121007. This roof was verified as meeting the building code requirements outlined on the mitigation affidavit.
