## COMMERCIAL WINDSTORM MITIGATION REPORT (OIR-B1-1802)

Countryside Key Homeowners Association, Inc.

473-483 Countryside Key Blvd

As of 4/29/2019  
FPAT File# MIT1811218

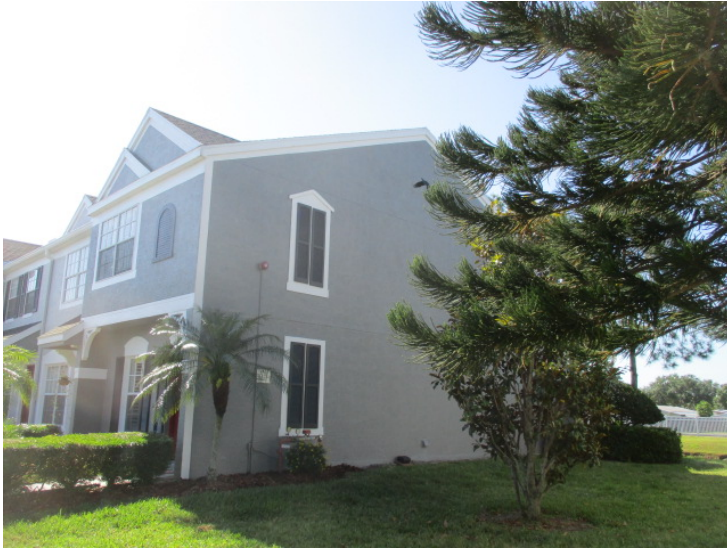
Exterior Elevation

- 5. Roof Geometry:**                    **Other Roof**  
Comments:                                      Inspection verified a gable roof shape.
- 6. SWR:**                                    **Unknown or Undetermined**  
Comments:                                      Due to no attic access we were unable to verify SWR.

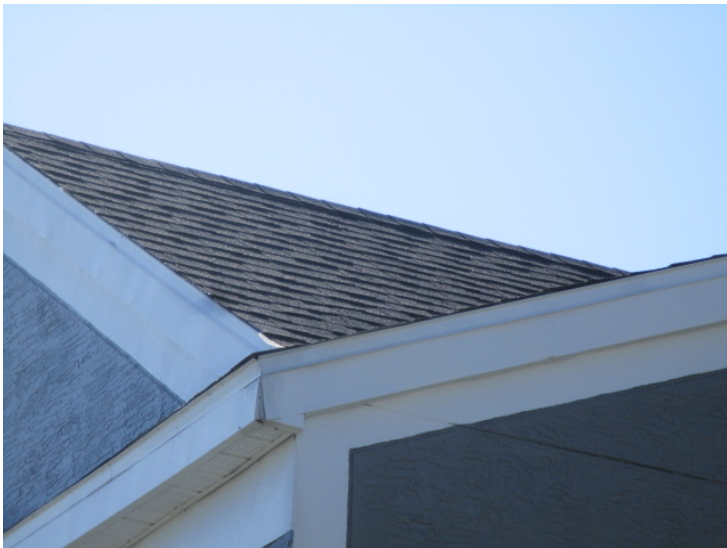
Roof Construction

- 2. Roof Covering:**                      **FBC Equivalent**  
Comments:                                      The roof covering was replaced in 2013. The roof permit was confirmed and the permit numbers are 20120785-20120783. This roof was verified as meeting the building code requirements outlined on the mitigation affidavit.
